Infrared Detection of Faulty Solder Joints

Phase 2.2

Contract F04606-80-C-1338

Program Report

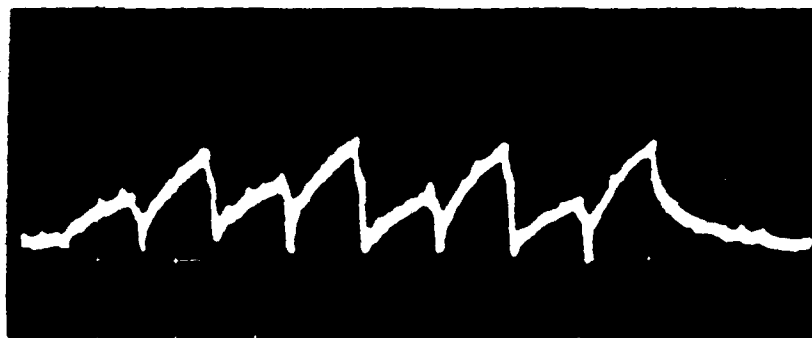
Figure 10 is a set of thermal signatures of these joints in their uncoated state. On the same vertical scale, Figure 11 shows the signatures after the joints had received an approximately 0.005"-thick coating of the resin.

Figure 10. Thermal signatures of uncoated joints.
